Contract #: 04-0120F4Cty: SF/Ala Rte: 80 PM: 13.2/13.9File #: 69.28**WELDING INSPECTION REPORT****Resident Engineer:**Siegenthaler, Peter**Address:** 333 Burma Road**City:** Oakland, CA 94607**Report No:** WIR-023250**Date Inspected:** 01-May-2011**Project Name:** SAS Superstructure**OSM Arrival Time:** 1900**Prime Contractor:** American Bridge/Fluor Enterprises, a JV**OSM Departure Time:** 700**Contractor:** Zhenhua Port Machinery Company, Ltd (ZPMC), Changxing Island **Location:** Shanghai, China**CWI Name:** See below**CWI Present:** Yes No**Inspected CWI report:** Yes No N/A**Rod Oven in Use:** Yes No N/A**Electrode to specification:** Yes No N/A**Weld Procedures Followed:** Yes No N/A**Qualified Welders:** Yes No N/A**Verified Joint Fit-up:** Yes No N/A**Approved Drawings:** Yes No N/A**Approved WPS:** Yes No N/A**Delayed / Cancelled:** Yes No N/A**Bridge No:** 34-0006**Component:** OBG Components**Summary of Items Observed:**

**OBG Trial Assembly Area**

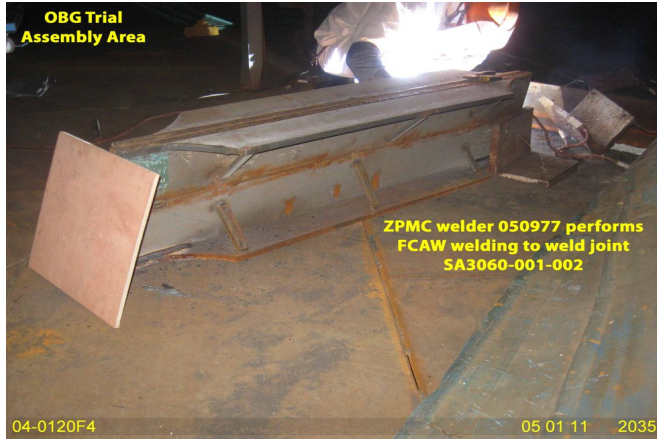
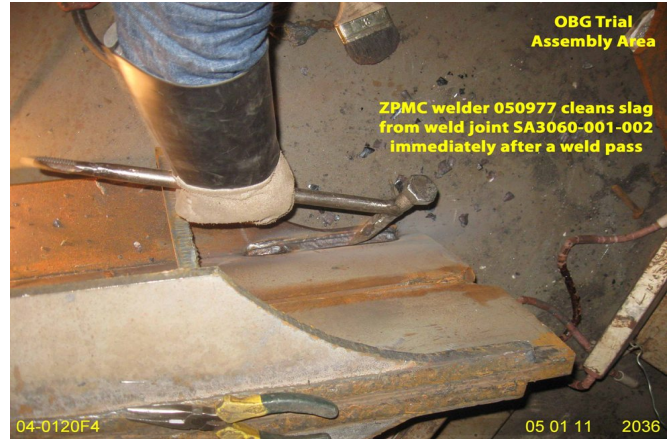
FCAW welding of weld joints SA3060-002-002, 008; SA3060-001-002 located on PCMK OBG Segment 13CE, kink splice sub-assemblies. Welder was identified as 050977. QC was identified as ABF CWI Bao Qian (QC1). Assisting QC1 at this location and appearing to be monitoring the welding operation and recording data was ZPMC QC Zhan Hai Feng (QCA1), who was not a CWI. Weld variables recorded by QCA1 appeared to comply with WPS-B-T-2231-ESAB as verbally identified by QCA1. See photos below of welding operation in progress.
